Typical 8 Harness Satin Double Cloth With Stitching Points

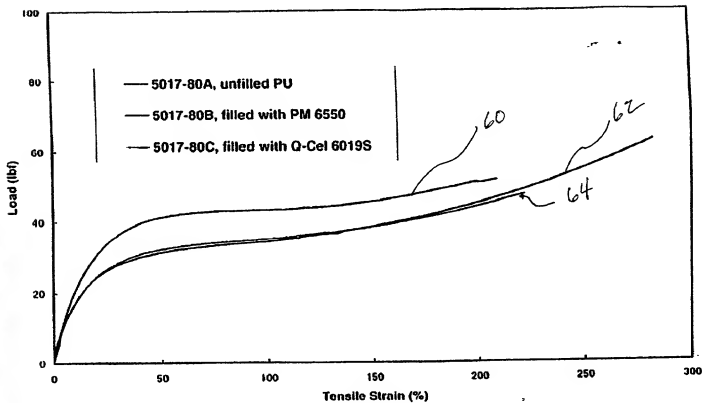
3A

Figure - Stress - Strain Results
